Detroit Water and Sewerage Department

Wastewater Master Plan

Review of Footing Drain Disconnection Projects

Technical Memorandum Original Date: August 8 2002 Revision Date: September 2003

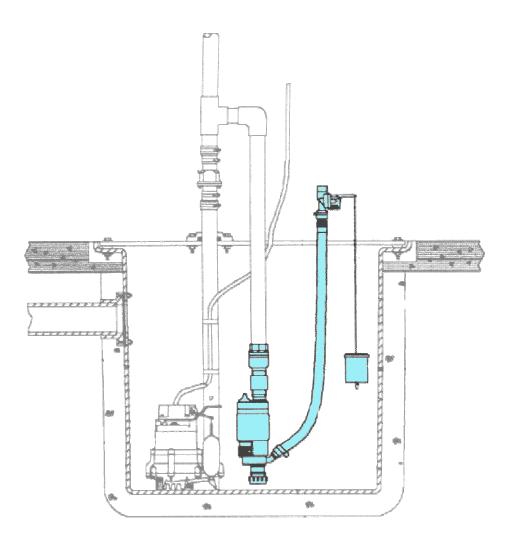
Figure 1 is a schematic of a typical sump installed with the footing drain disconnected from the sanitary sewer line. Footing drain flows empty to the sump where a primary and backup pump discharge flows out to a drainage field or storm sewer. Figure 2 is a picture showing what a typical installation looks like. In this case, the backup pump is powered by water pressure in the event of a power outage.

Figure 1 –Sump Pump Installation Schematic

A brief description of each of the communities contacted is provided below. More detailed descriptions are included in the tables that follow. Figures 1 and 2 at the end of this document show examples of footing drain disconnection.

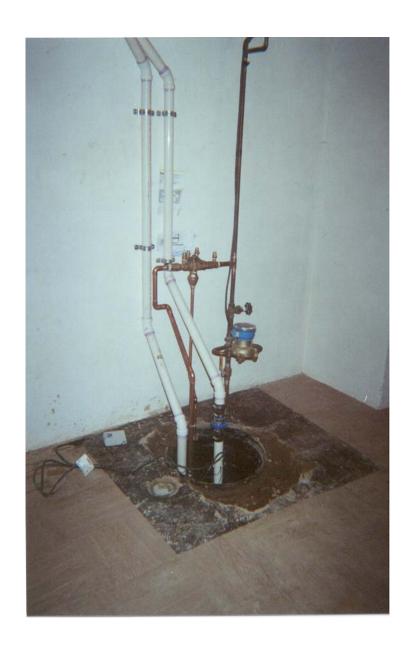
Figure 2 –Sump Pump Installation with Water Pressure Powered Backup Pump
